ALMONESSON LAKE DAM

NJ 00401

PHASE 1 INSPECTION REPORT NATIONAL DAM SAFETY PROGRAM

February, 1979

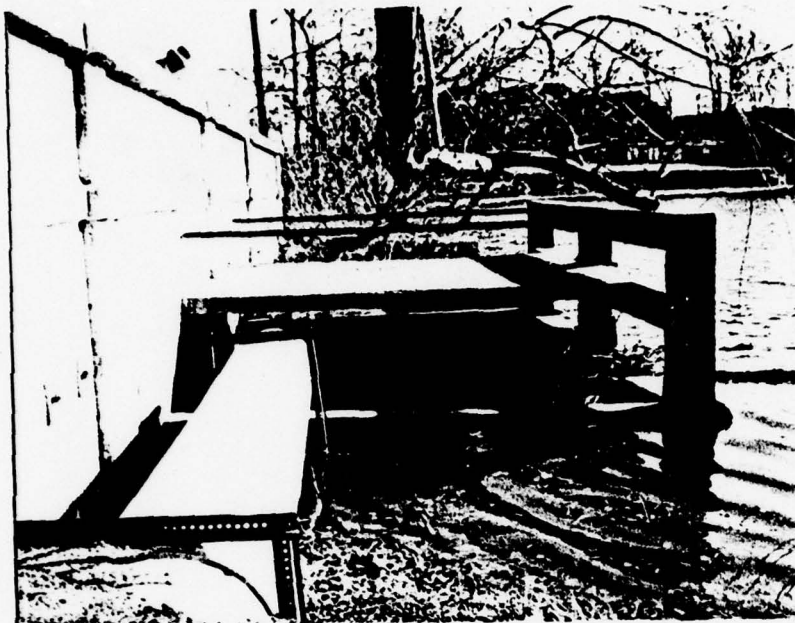
Spillway structure

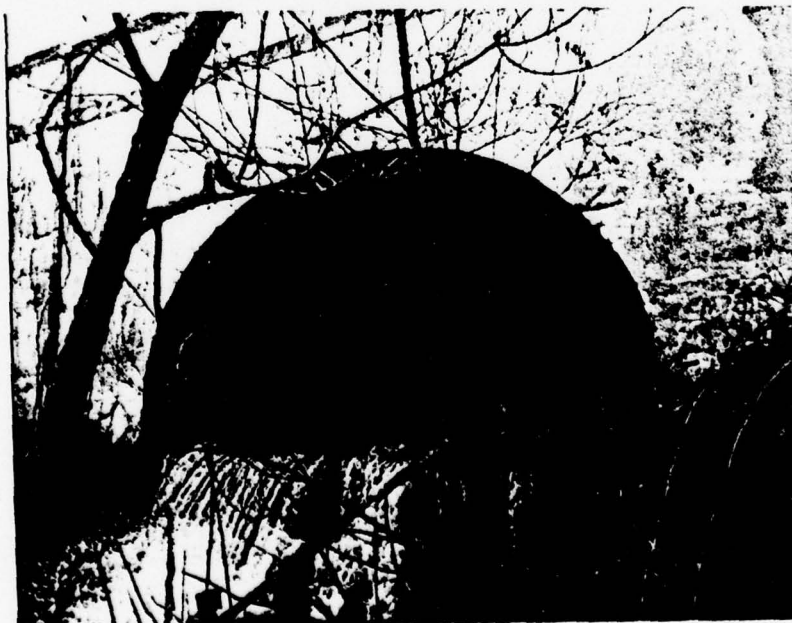
At the outfall invert of the culvert (on the north bridge fascia) there is a drop of about 4.5 feet to the downstream channel and vertical steel sheeting has been driven at roughly 45° angles from the fascia line to protect the toes of slope at the base of each wingwall. Some loose riprap has been dumped into the outfall channel (which replaces 2 x 8 timber lagging originally constructed in this area). The drop in the outfall appears to be the long term result of erosion and scour.

Downstream bridge opening (22' dia.)
